Home Condition Survey

8, Rowan Way
NORTHAMPTON
NN5 0DT

Report Reference No: 5359009
Date: 26-May-2015
Surveyor: Mrs Carolyn Clay

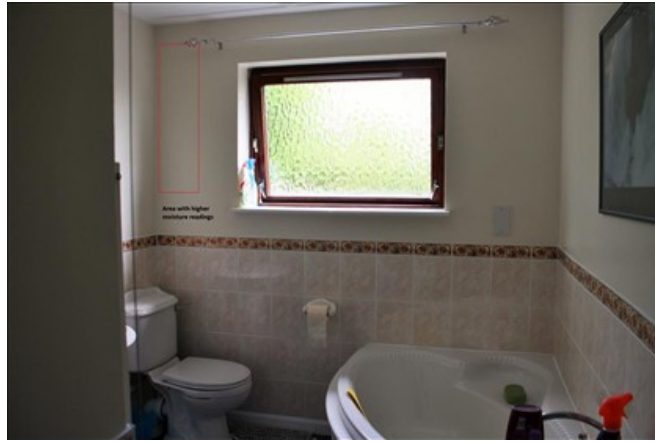
Tests revealed that there is a small area with higher readings to the rear elevation of the Main Bathroom. See Section E3.

Main bathroom showing area with damp

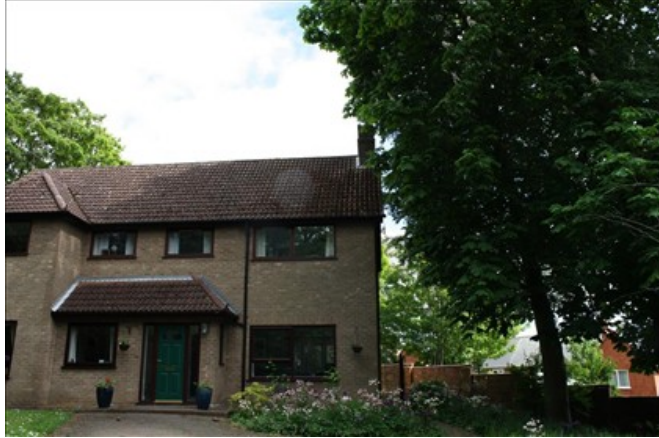
I understand that at least one tree within the boundary of the property has a Tree Preservation Order.

Tree to RHS of house

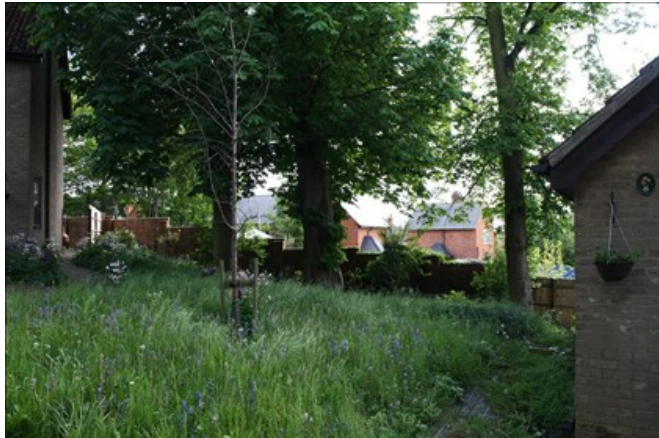
<p>There is no evidence of structural movement.</p> <p>The property is situated in an area in which the sub-soil may include shrinkable clay. There are a number of trees located close enough to the property to cause possible damage.</p>
--

Trees to RHS of house

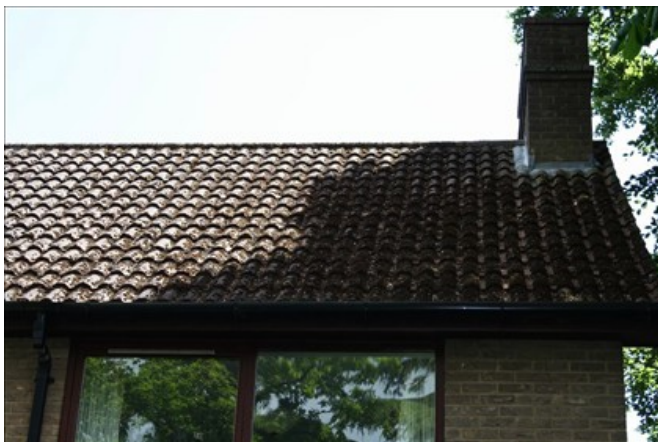
Front roof, some moss and leave covering

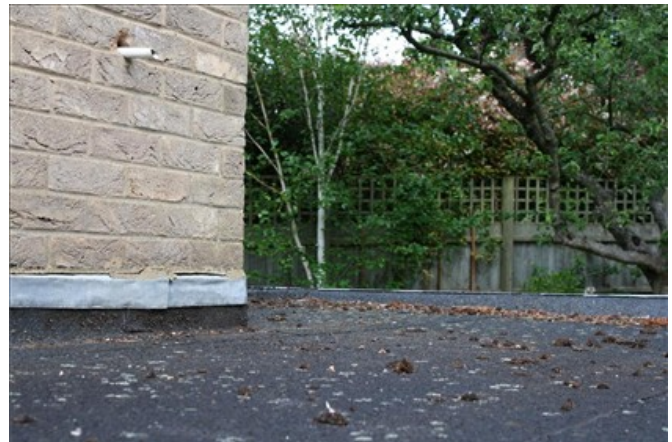
D2. Roof coverings Flat Roof	The Utility Room roof is flat and covered with roofing felt. The felt is in good condition. No repair is presently required. Normal maintenance must be undertaken.	1

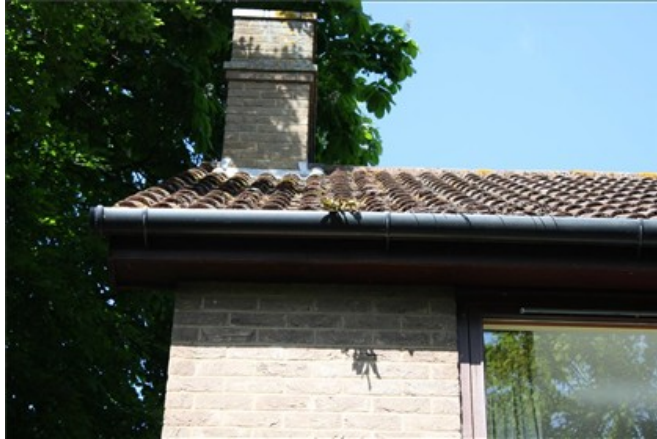
D3. Rainwater pipes & gutters	<p>Gutters and downpipes are the original, formed in PVC and are supported by plastic brackets fixed to the fascia board.</p> <p>Gutters are in generally acceptable condition.</p> <p>It is essential that the gutters are kept free of debris, such as leaves, as this can prevent proper draining resulting in rot and decay to other parts of the building. Due to the number of trees in this garden the gutters should be cleared on a regular basis as part of a maintenance program.</p>	1
--	--	---

Rear Roof, leaves on roof and in gutter

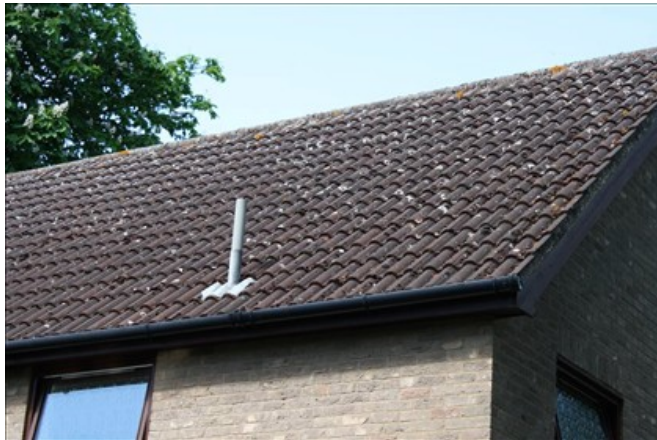
D4. Above ground waste & soil pipes	<p>The above ground waste water pipes are plastic.</p> <p>The bathroom soil and vent pipe terminates above the rear roof.</p> <p>There is no cover or wire cage on the top of the soil and vent pipe. This should be fitted to stop leaves and other debris blocking the pipe.</p>	2
--	--	---

uncapped soil and vent pipe

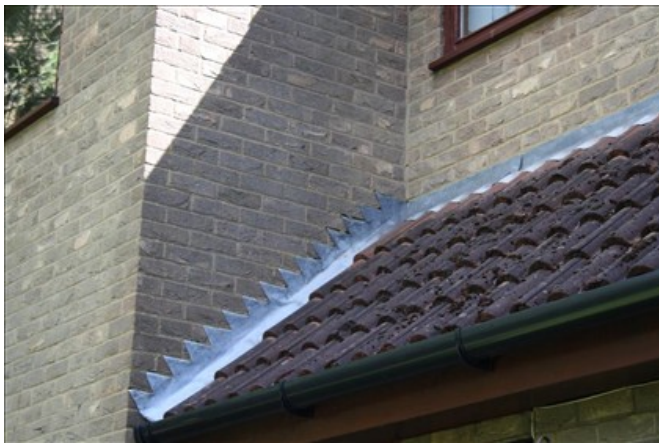
D5. Main walls (including claddings)	<p>The outside walls are brick-faced and of cavity construction.</p> <p>The location of the damp proof course was identified but its composition could not be determined because of pointing to the brick joint. However, from the age of the construction, it is likely to be formed in PVC.</p> <p>Small cracks are present in the outside wall. These are old and are not indicative of current or continuing movement.</p> <p>There are some small areas with missing mortar which should be replaced as part of a maintenance program.</p> <p>The inspection revealed that the damp proof course is operating satisfactorily and no evidence of rising dampness was discovered. It is essential that adjacent ground levels are maintained at least 150mm [two brick courses] below the level of the DPC.</p>	1
---	--	---

porch roof meets wall - some missing mortar

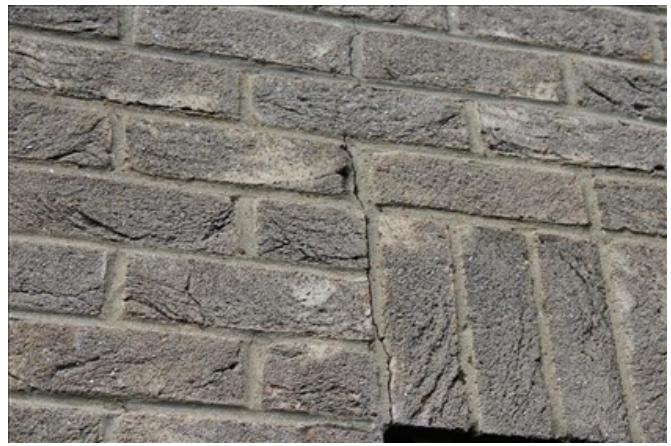
Crack to wall above patio doors

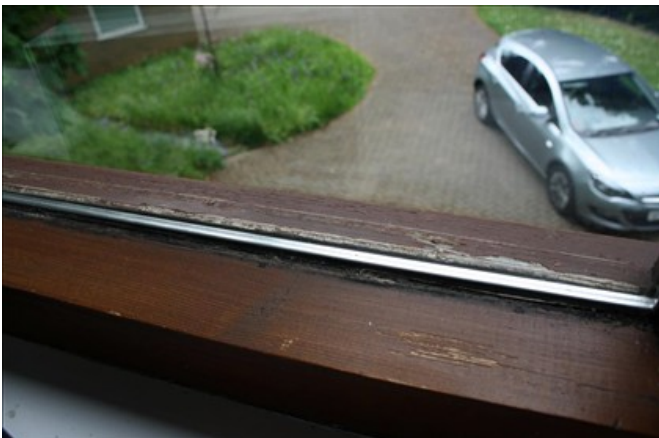
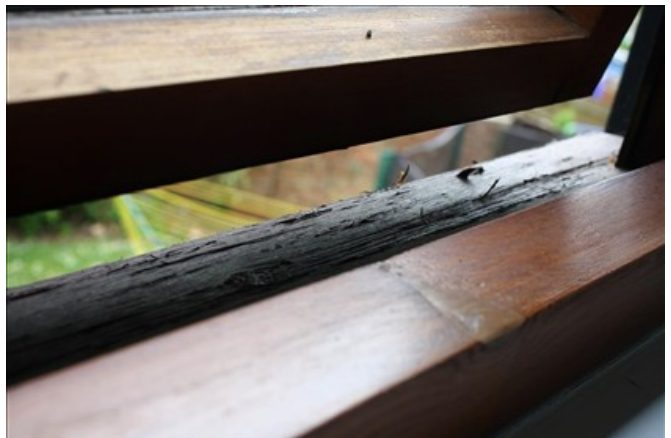
<p>D6. Windows</p>	<p>The first floor timber casement windows are the original and double glazed.</p> <p>The ground floor windows have been replaced with uPVC double glazed windows within the last year.</p> <p>There was no evidence of failure of the seals of the double glazing which would be displayed as condensation or misting between the glazing panes.</p> <p>Some of the first floor windows do not open sufficiently to allow a person to escape in the event of fire. See Section C Risks to People</p>	<p>1</p>
<p>D7. Outside doors (incl. patio doors)</p>	<p>External doors are formed in uPVC with sealed double glazed units set in a uPVC surround.</p> <p>The patio doors in the Lounge are formed in uPVC. Safety glass has been used.</p> <p>The doors are in acceptable condition.</p> <p>The operation of the doors and their locking mechanisms is satisfactory. However, as you will be unaware of who may hold keys to the property, it would be a sensible idea to change the external locks.</p>	<p>1</p>

Internal 1st floor window

External & Internal 1st floor window

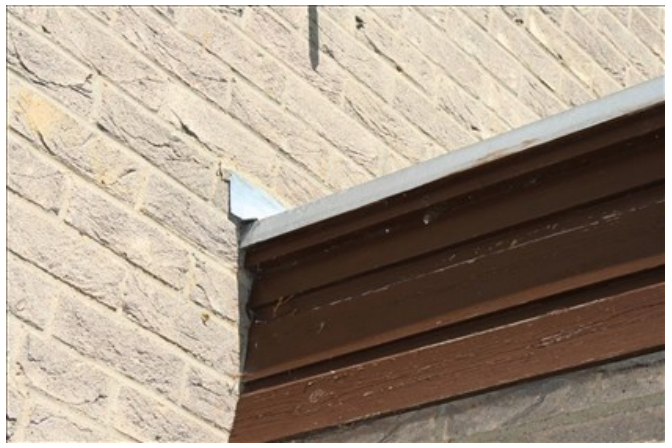
<p>D8. Other external woodwork etc</p>	<p>Fascias [facing boards to which the gutters are attached], soffits [horizontal boards which fit between the fascia board and the wall and bargeboards [timbers which edge the gable of the roof] are the original softwood timber.</p> <p>No repair is presently required. Normal maintenance must be undertaken.</p>	<p>1</p>
<p>D9. Outside decoration</p>	<p>Decorated areas may include such items as windows, doors, walls, timbers at roof edges, porches.</p> <p>The external timbers are stained.</p> <p>The staining to the first floor windows, window and door cills, and Utility Room fascia is flaking and requires renewing.</p>	<p>2</p>

Timber board to edge of flat roof

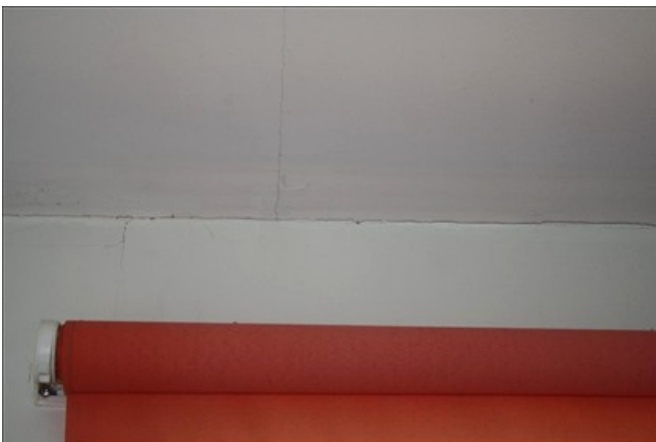
E2. Ceilings	<p>All the ceilings are formed in skimmed plasterboard and the ground floor ceilings are finished with a textured coating, which due to the age of construction MAY contain a small element of asbestos. (See Section C Health and Safety and the Fact Sheet attached to the report.)</p> <p>There are plaster covings to the junctions of the walls and ceilings in some areas.</p> <p>Some ceilings display minor cracks which follow the joints of the boards. This type of cracking is common in construction of this type and is not indicative of any underlying fault.</p> <p>No repair is presently required. Normal maintenance must be undertaken.</p>	1
-------------------------	--	----------

minor cracking where ceiling meets wall

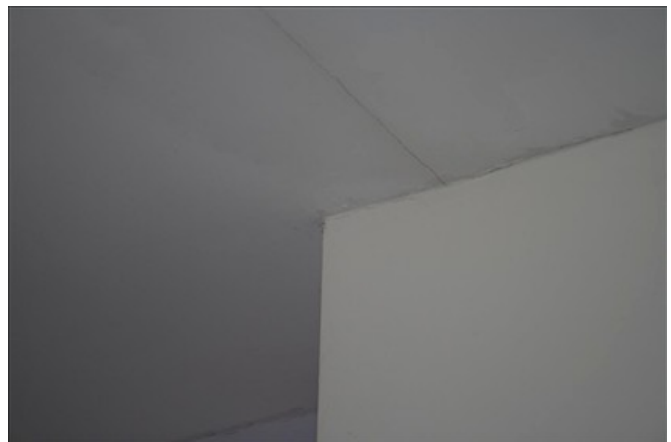
cracking along ceiling plasterboard joints

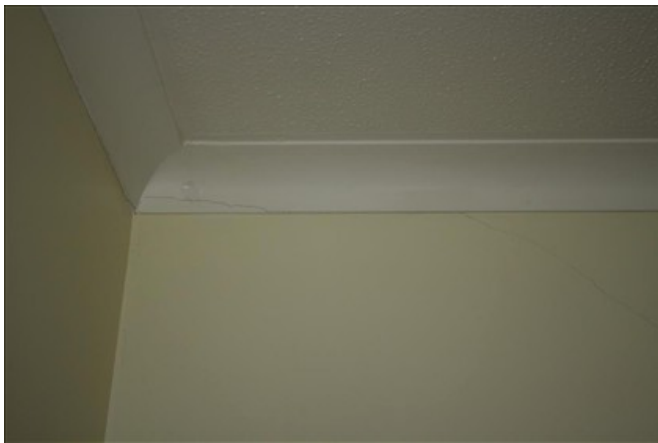
<p>E3. Inside walls, partitions & plasterwork</p> <p>All other walls</p>	<p>The internal walls and partitions are partly of masonry and partly of timber construction and have been finished with a plaster finish.</p> <p>There are minor cracks in a number of places, notably at the junctions of the walls and ceilings. This is common with this type of construction and not significant of any underlying defect.</p> <p>No repair is presently required. Normal maintenance must be undertaken.</p>	<p>1</p>
---	--	----------

minor cracking

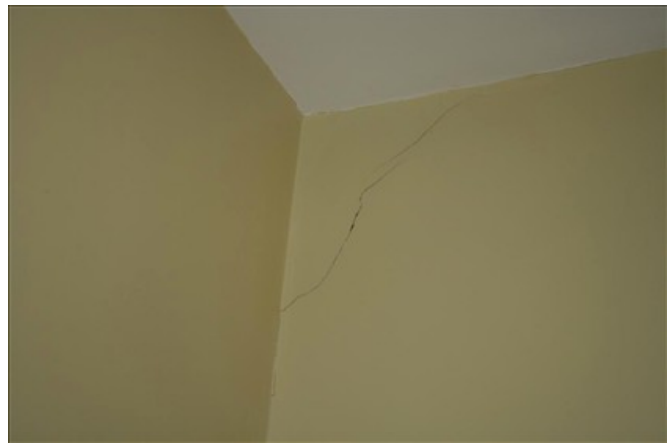
cracking in Dining Room

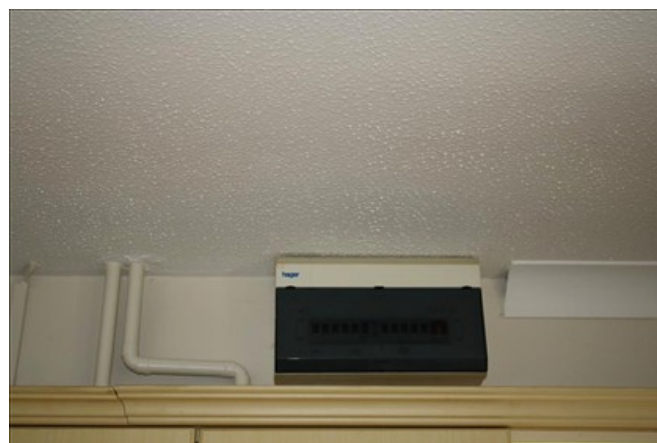
F1. Electricity	<p>The property is connected to the main electricity supply and the meter is located in an external box.</p> <p>The consumer unit [fuse box] is a modern RCD unit which has been fitted in the last 10 years. The power sockets are provided on a modern ring main and lighting is provided to every room.</p> <p>The provision of power outlets could be considered insufficient for modern requirements which increases the temptation to use extension leads. These can present a variety of hazards and should be avoided.</p> <p>No recent test certificate is available. The absence of such a test certificate is a hazard [see Section C] and necessitates the imposition of a Condition 3 Rating.</p>	3
------------------------	--	----------

Consumer unit, above kitchen cupboard

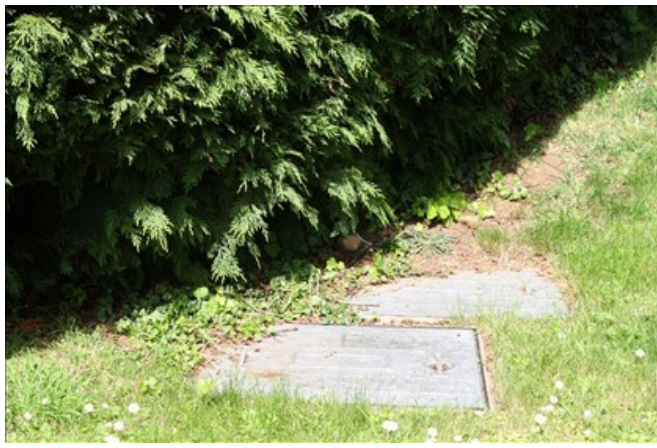
<p>F6. Drainage</p>	<p>it was not possible to lift the access covers as they are partly buried.</p>	<p style="text-align: center; font-weight: bold;">NI</p>
--------------------------------	---	--

Inspection chambers not opened

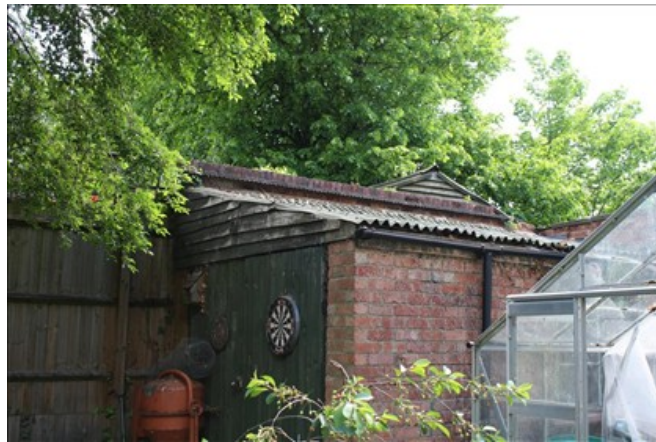
Rear outbuilding

The outbuilding to the rear is of brick construction, with a corrugated roof and is in a poor condition. The outbuilding was locked and only inspected externally but I believe that the roof leaks and should be replaced in the near future to prevent further damage.

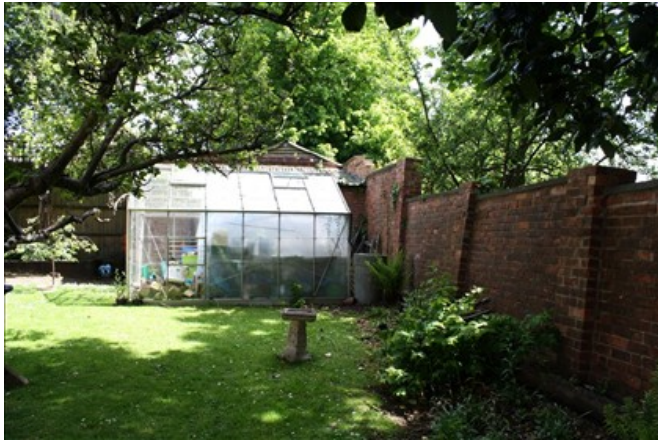
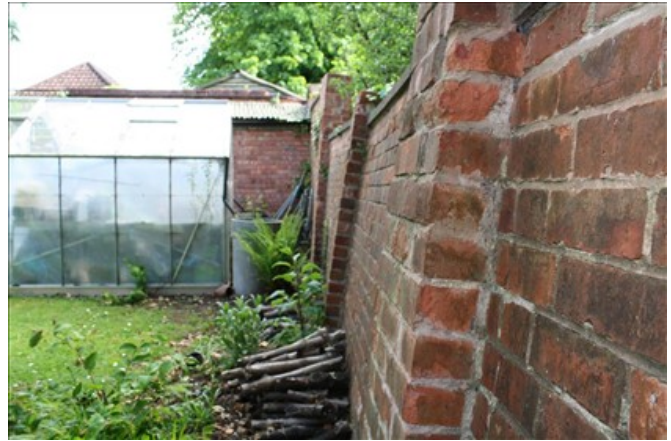
Rear boundary wall

The boundary rear walls are brick built. These are in a poor condition and some works of repair are required. The wall leans away from the property but is supported on the other side by brick piers. These piers should be maintained regularly to ensure that the wall does not fall over.
