Home Condition Survey

8, Rowan Way
NORTHAMPTON
NN5 0DT

Report Reference No: 5359009
Date: 26-May-2015
Surveyor: Mrs Carolyn Clay

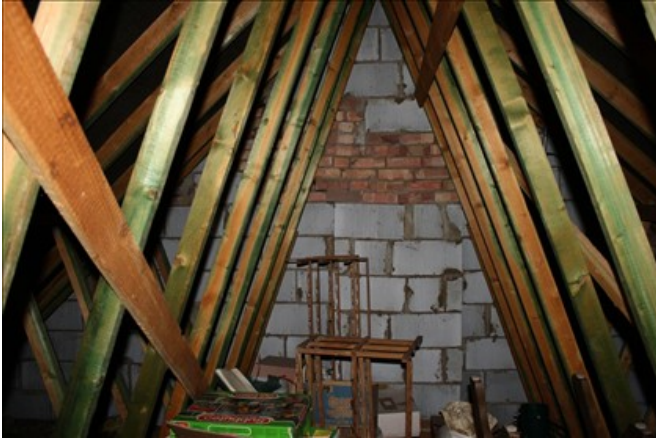
Loft structure

Description and Justification for Rating and any comments	Condition Rating
E1. Roof structure	<p>The roof structure uses standard pre-formed timbers trusses held together with nail plates. Lateral movement is restrained by straps tying the roof to the gable walls and bracing timbers with the roof in accordance with good practice. The sarking felt under the roof tiles can be viewed. See Section D1</p> <p>The insulation within the roof is in fibreglass quilting which is laid between the joists to a depth of approximately 200mm.</p> <p>The presence of the boarding to the middle section restricts the inspection of insulation and joists in this area.</p> <p>No repair is presently required. Normal maintenance must be undertaken.</p>	1

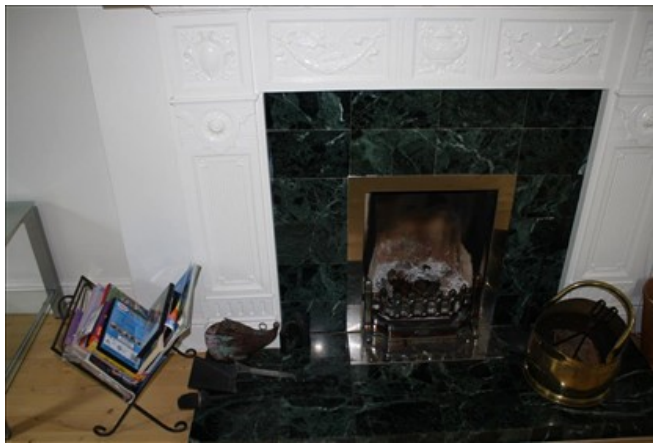
Fireplace

<p>E5. Fireplaces & chimney breasts</p>	<p>The chimney breast is of masonry construction and a fireplace remains in the Lounge. There is evidence that this is currently in use as a log fire.</p> <p>I have not carried out a smoke test of the chimney as this is beyond the scope of this inspection. Before any open fire is lit you should seek the advice of a HETAS approved chimney sweep. (for more information see the HETAS website at www.hetas.co.uk/find-chimney-sweep/).</p>	<p>1</p>
---	--	----------

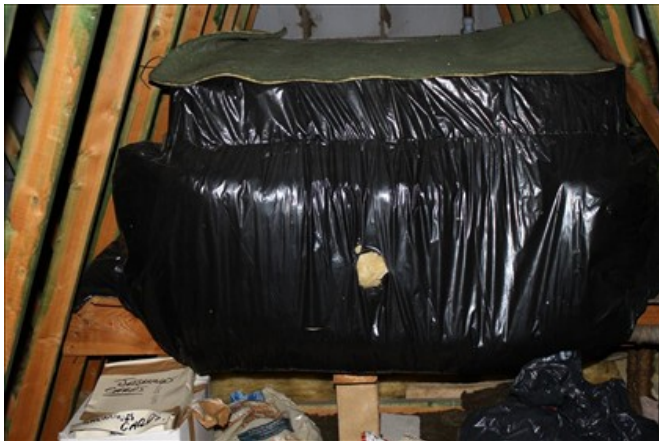
Cold water tank in loft space

<p>F4. Water</p>	<p>The property is connected to the mains water supply. The internal stopcock is beneath the sink in the utility room. The incoming mains supply pipe is in copper.</p> <p>Within the loft, there are two tanks. One is for cold water storage and the other is the expansion tank for the central heating and hot water boiler. They are formed in PVC and are provided with lids, insulation and overflow pipes.</p> <p>Hot water is produced by the central heating boiler and stored in a factory insulated copper cylinder in the master bedroom. There is an emersion heater and a fitted thermostat.</p> <p>No leaks were discovered from the tanks or the surrounding pipework.</p> <p>No repair is presently required. Normal maintenance must be undertaken.</p>	<p style="text-align: center; color: green; font-weight: bold;">1</p>
-----------------------------	--	---

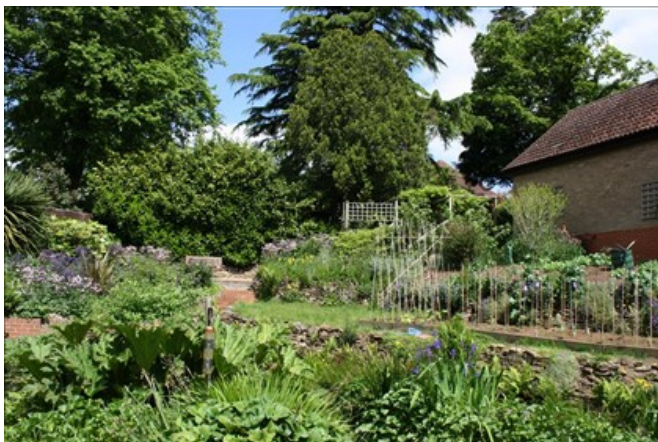
Garden

The grounds contain mature trees, shrubs, ponds, a vegetable plot and lawn.
